**The Los Angeles Regional Water Quality Control Board**  
320 West Fourth Street, Suite 200  
Los Angeles, CA 90013

**Santa Susana Field Laboratory**  
**Site-Wide Stormwater Annual Report**  
**2022/23 Reporting Year**

CWR0801  
October 2023

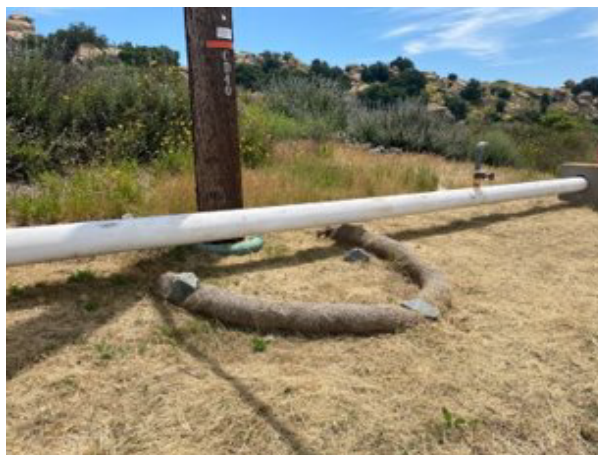
2022: R1 Pond Berm Repair

Stormwater from Outfall 011 is pumped to the R-1 Pond for settling and evaporation. The pond also serves as added storage to reduce stormwater discharges. When the runoff exceeds the storage capacity of the pond, stormwater is treated using an advanced SWTS. Treated stormwater is discharged at Outfall 011 and then flows through a natural channel to Outfall 001. Following the November 2018 Woolsey Fire, conveyance pipelines to the Outfall 011 SWTS were damaged and stormwater runoff at Outfall 011 was instead treated only by a flow-through media filter for the 2018/19 water year. The Outfall 011 SWTS was repaired in late 2019 and operational again prior to the first 2019/20 storm event. During the 2021/22 season, a berm on the R-1 Pond was compromised during the peak 24-hr rain event on 1/1/2022, causing the pond to discharge before reaching its capacity under typical operations resulting in stormwater discharge at Outfall 011 that was partially treated by the media filter at the outfall. The berm underwent repair in October 2022, to restore the pond volume to its full capacity.

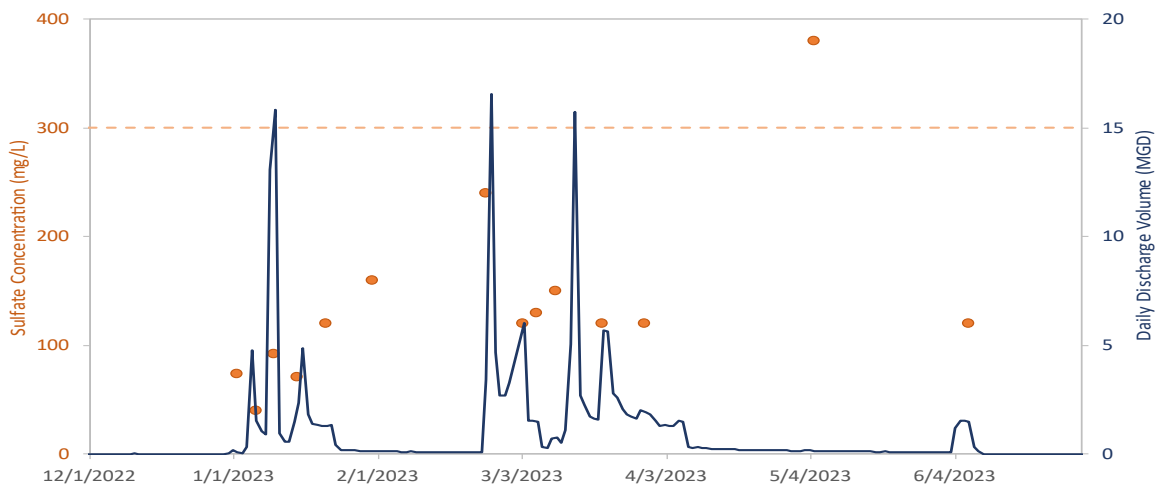
Figure 24. Outfall 002 Sulfate Concentration (and 300 mg/L Benchmark) vs Daily Discharge Volume at Outfall 002

The Santa Susana Formation, which is found in just the southwest corner of SSFL, contains shale and shaly sandstone. In contrast, the Chatsworth formation, which covers the rest of the site, is entirely sandstone. Shale is known to contain sulfur which further helps to explain the high sulfate reported by the Groundwater Expert Panel in seeps above and below Outfall 002 (and nearby offsite). Additionally, sulfate concentrations in stormwater samples at the site are typically highest during baseflow periods and late in the wet season when the water table is highest, as shown in Figure 24. **Together, these lines of evidence demonstrate that the sulfate exceedance at Outfall 002 is most likely from natural sources.** Additionally, the 2022 SRAM<sup>6</sup> excludes sulfate from its constituent list because it is a “naturally occurring, low-toxicity chemical” and doesn’t present a human or ecological health risk.

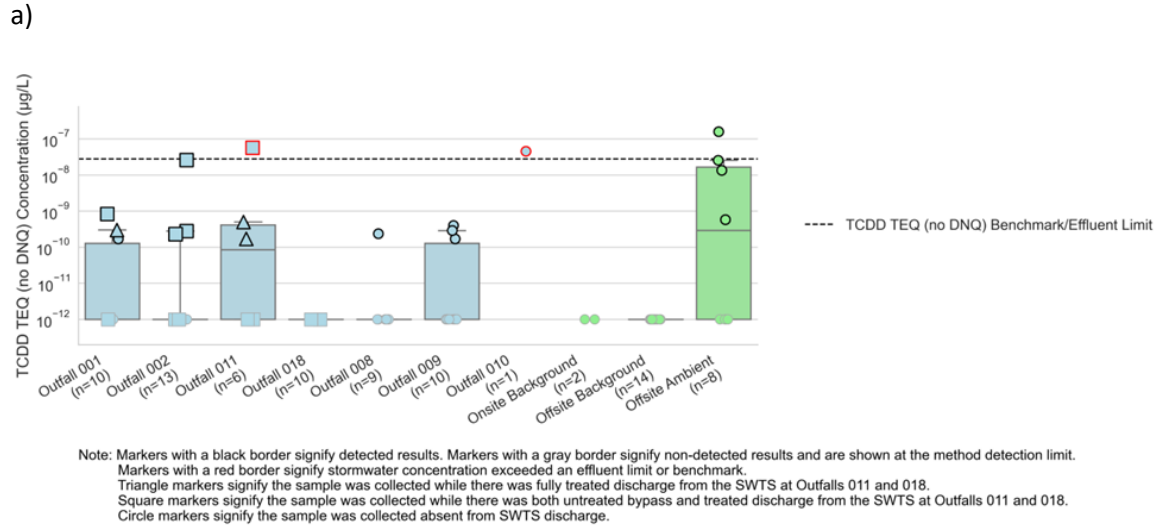
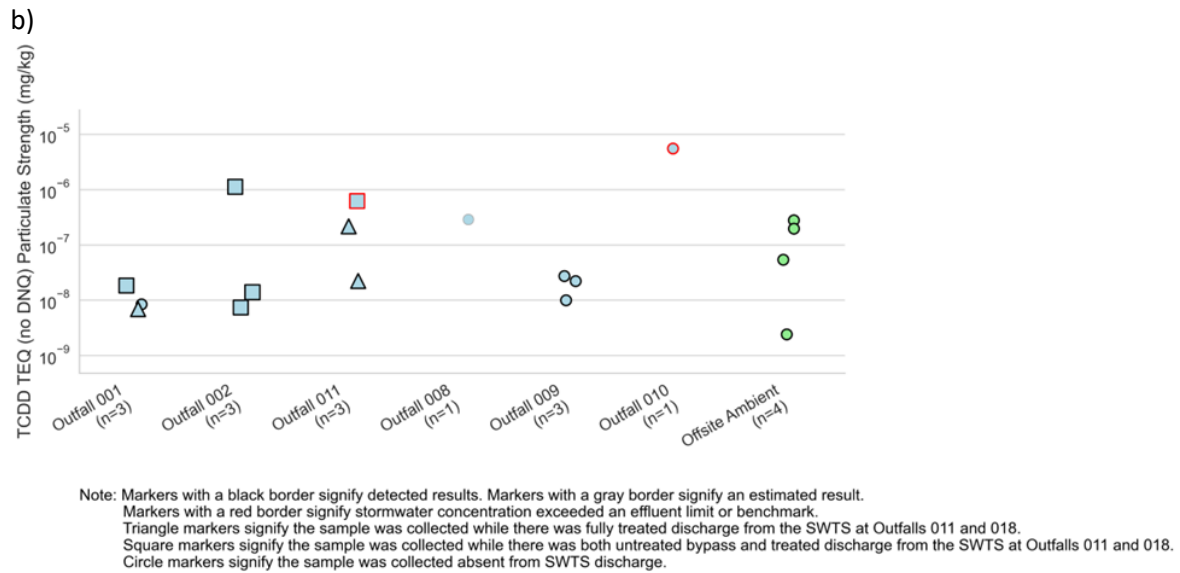
Figure 25. 2022/23 Dioxins Concentrations and Particulate Strengths by Outfall

Figure 25a shows the 2022/23 outfall concentrations of TCDD TEQ (no DNQ), including the exceeding samples at Outfall 011 and Outfall 010. Figure 25b shows the outfall PS values of TCDD TEQ (no DNQ), with the highest PS value located at Outfall 010. **The spatial patterns indicates that while all outfalls likely shared the same diffuse, site-wide source of TCDD TEQ (no DNQ) in stormwater, there may be localized sources with higher TCDD TEQ (no DNQ) concentrations that drives exceedances.** Looking at the offsite background and ambient (open space with roads and rural residential) stormwater indicates that there are ambient sources of TCDD TEQ (no DNQ) present at the site that could be contributing to the exceedances.

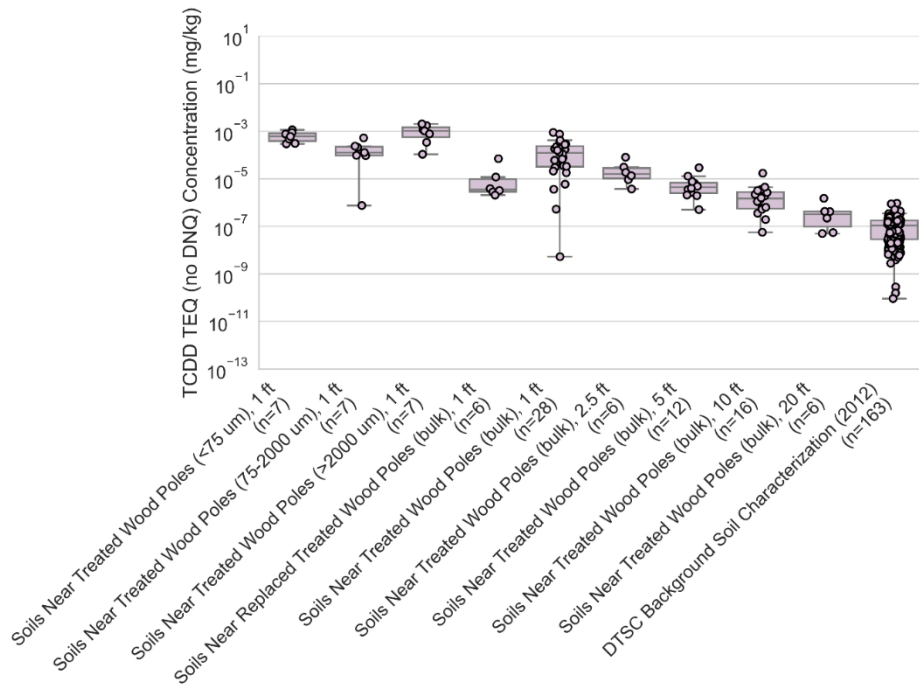
Figure 27. TCDD TEQ (no DNQ) Concentrations in Soils at Varying Distances from PCP-Treated Wood Utility Poles Compared to Background Soil Concentrations

Based on multiple lines of evidence, most of the 2022/23 exceedances are believed to be from natural background soils and non-industrial sources (e.g., elevated TCDD TEQ no DNQ in soils near treated wood poles). Only the TCDD TEQ (no DNQ) exceedance at Outfall 011, which occurred during a large storm that caused bypass at the stormwater treatment system, was found to potentially have contributions from impacted soils based on concentrations measured in surface soils in the drainage area. However, on average, the majority of surface soils in potential cleanup areas in this watershed have TCDD TEQ (no DNQ) concentrations similar to background soils, with just the highest percentile concentrations exceeding those of background datasets, on par with soil concentrations near treated wood poles. Where impacted soils could not be ruled out as a source, new BMPs or improvements/repairs are proposed.
