Santa Susana Field Laboratory (SSFL) Site-Wide Stormwater Public Meeting

November 29, 2023

SSFL Surface Water Expert Panel

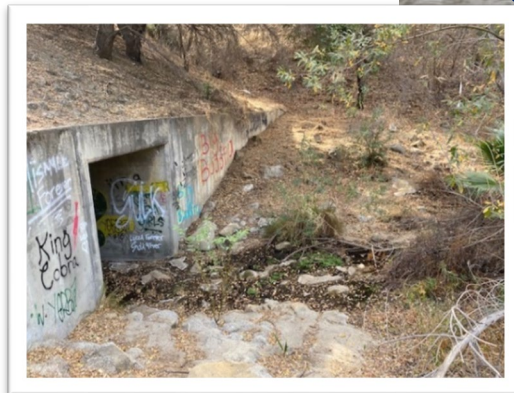
Oblique view of north-flowing watersheds and Brandeis

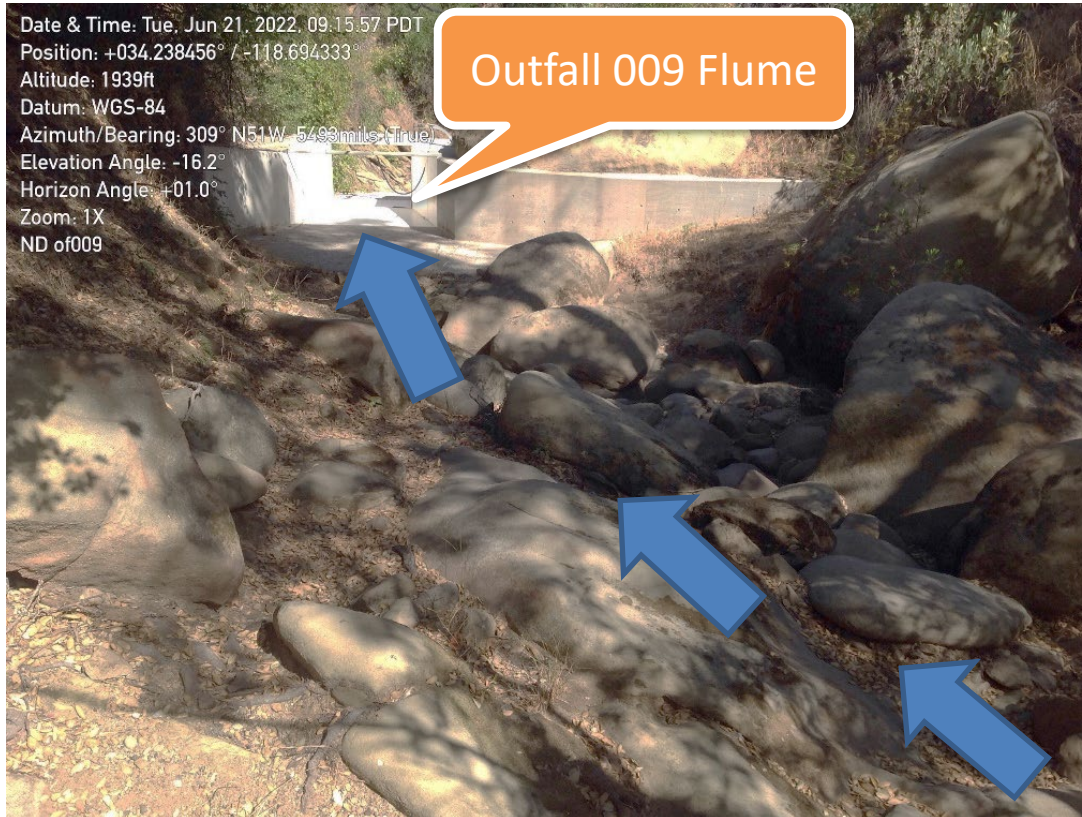
NPDES Outfall Example: Looking Downstream Toward Outfall 009

- All flow in the stream/drainage is directed into the flume
- Sample collection and flow measurements occur in the flume
- Every outfall is equipped with an autosampler and flow meter

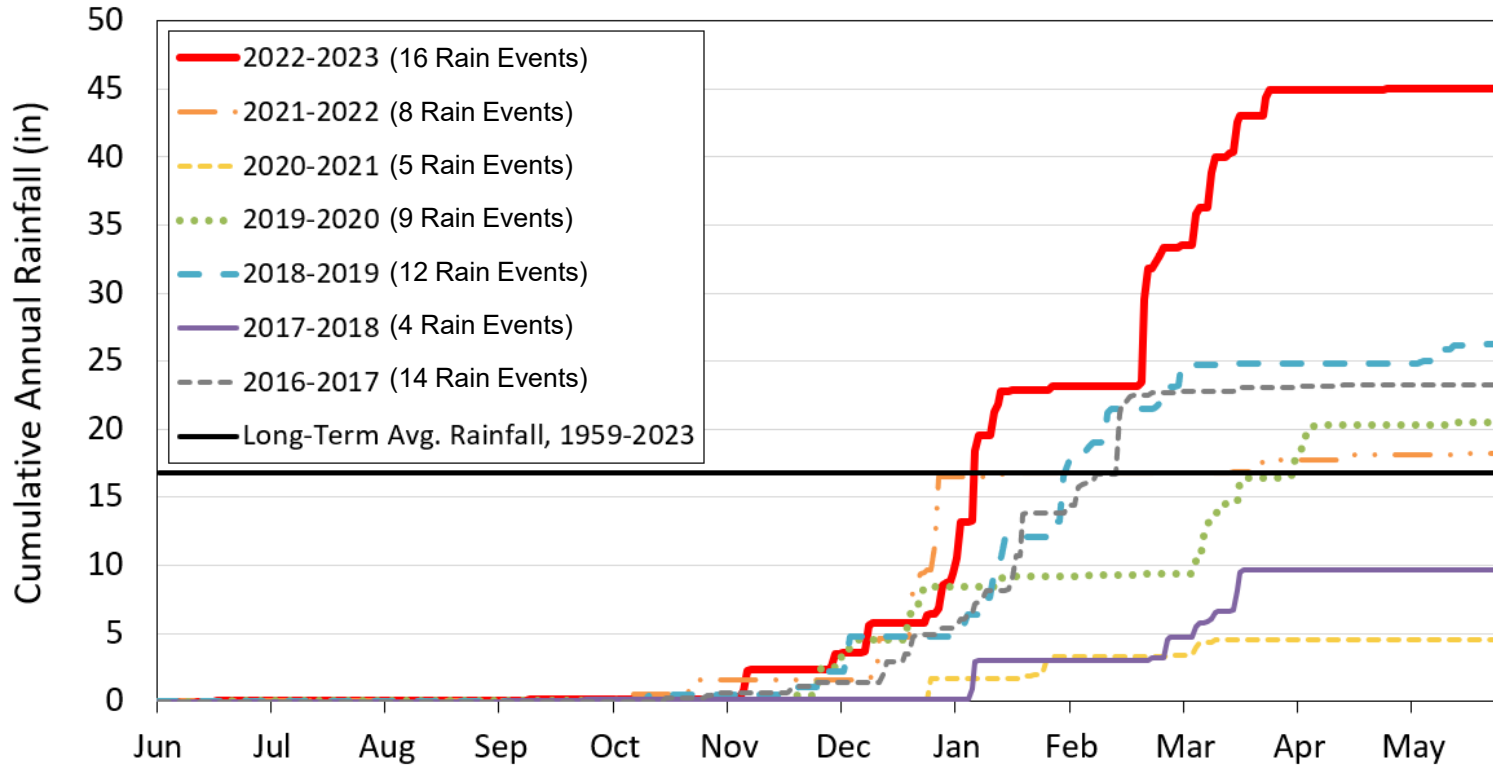
2022/2023 Rainfall

Highest annual rainfall total in the 64-year-long record at the site

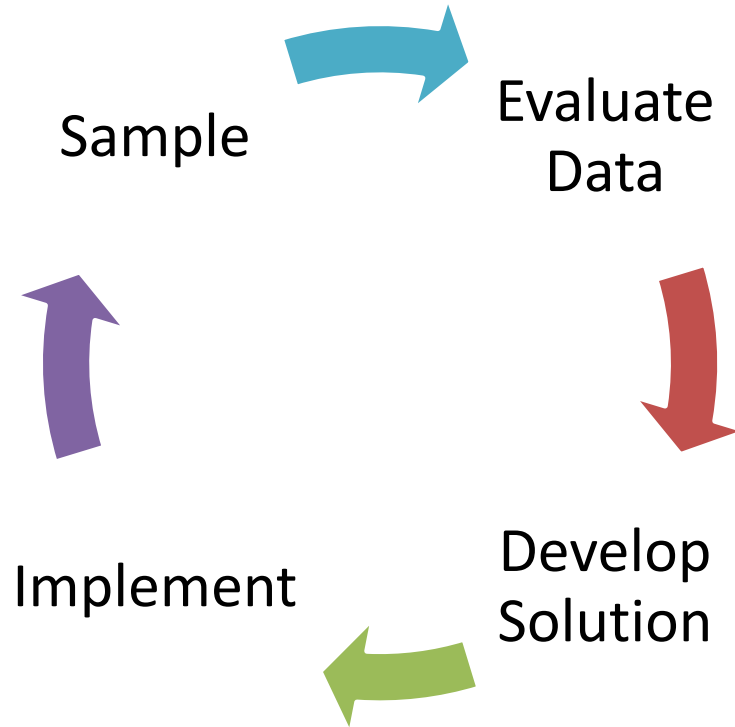
Panel's Process for Stormwater Quality Management

Example: Lead at Outfall 009

1. Outfall sample result shows exceedance of permit limit
2. Subarea results were evaluated and confirmed that impacted Shooting Range soils likely contributed
3. Existing Shooting Range BMPs evaluated, improvements identified, and targeted accelerated source removal (lead shot along trail) requested
4. Requested actions implemented

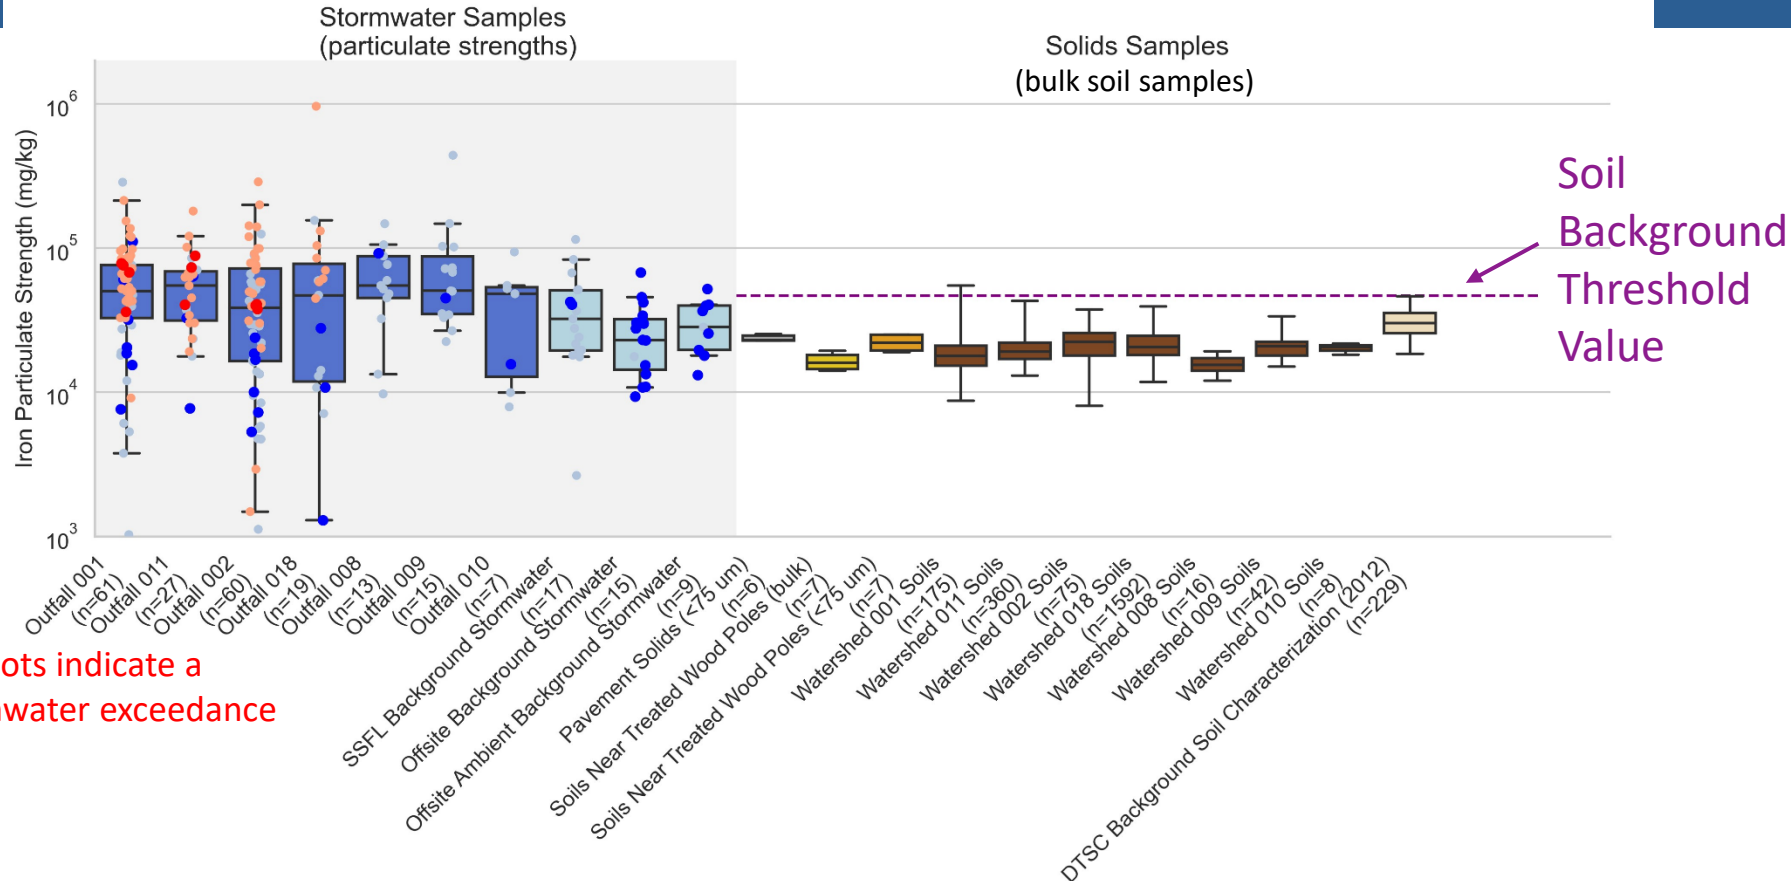
Source Investigation Example: Iron Particulate Strength

Red dots indicate a stormwater exceedance

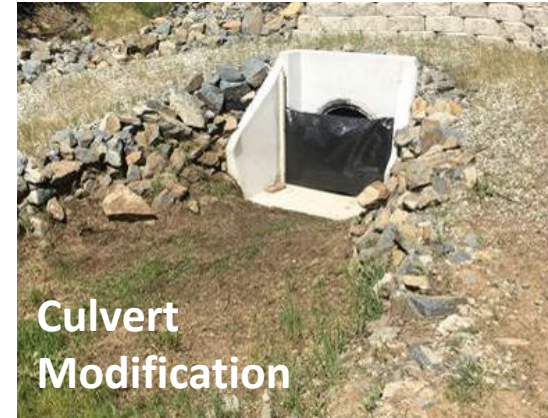
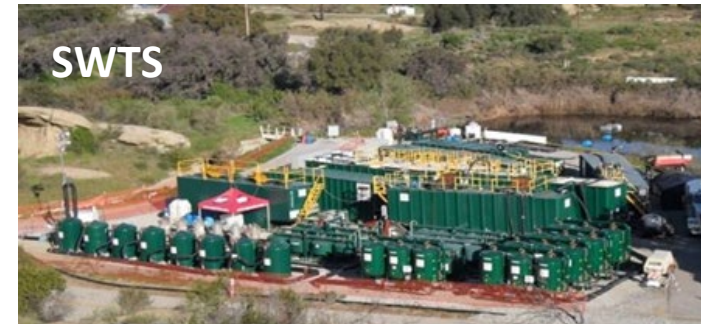
Existing Structural Controls

- **Distributed Passive Treatment BMPs**
 - Filter media mix developed for SSFL BMPs consisting of sand, zeolite, and granulated activated carbon (GAC)
 - Located throughout Outfall 009 Watershed
 - Variety of formats depending on space available
 - Culvert Modifications (CMs) and Media Filters
 - Lower Lot Biofilter
 - Detention Bioswales
 - ELV Treatment BMP
- **Active stormwater treatment systems (SWTS)**
 - Coagulation, sedimentation, and filtration plants in Outfall 011 and 018 watersheds

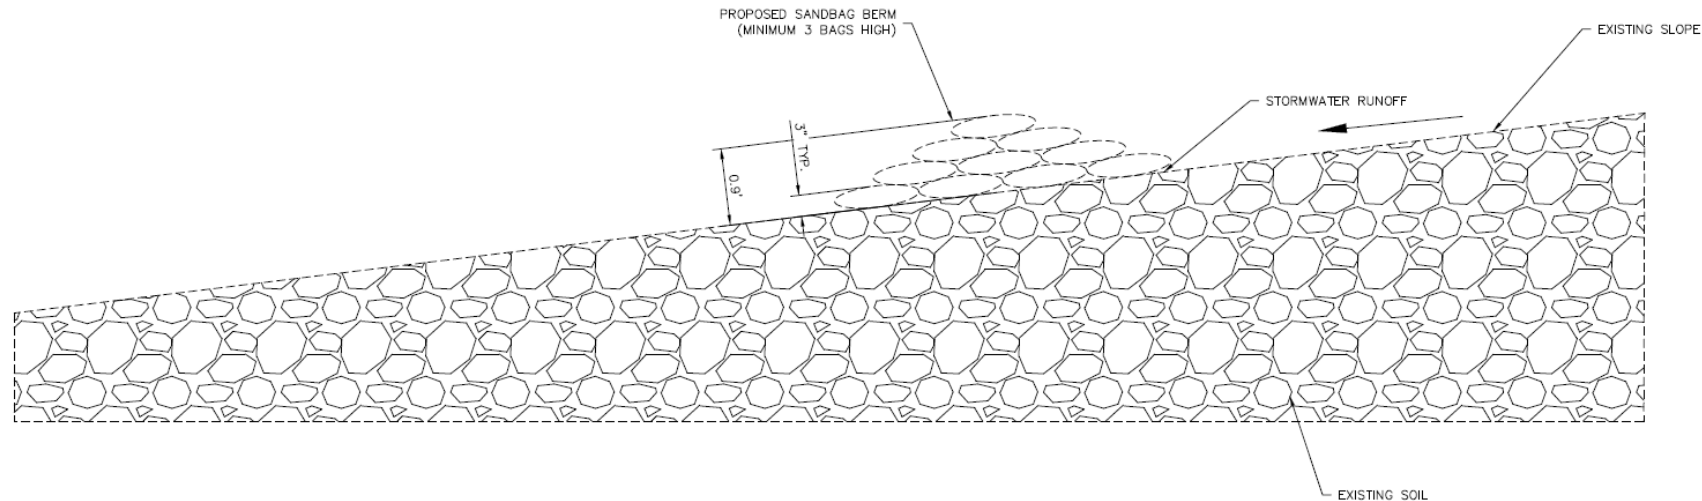
TYPICAL SANDBAG BERM CROSS SECTION — EXISTING GRADE DESIGN

Area I Burn Pit Stormwater Capture and Conveyance

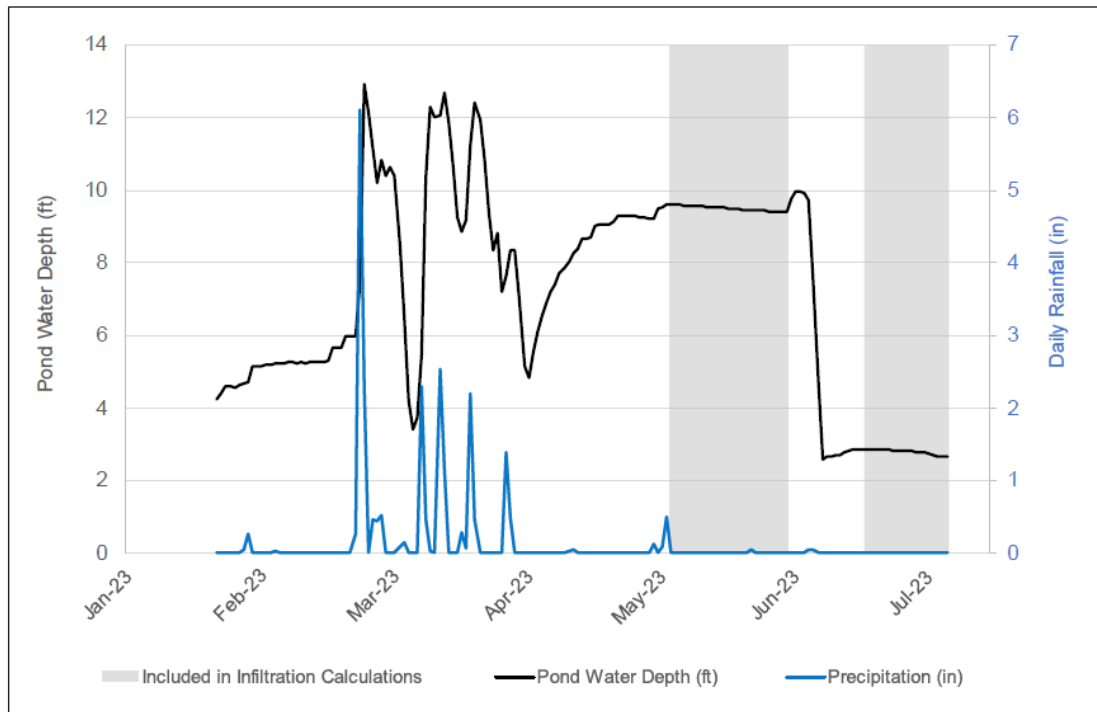
Figure 1. Water Depth and Precipitation at **Silvernale Pond**: January 23 – July 6, 2023 (gray shaded areas indicate infiltration calculation periods)

Utilizing water level measurement rainfall, and evapotranspiration records, infiltration rates were assessed through mass balance analysis in ponds upstream of Outfalls 011 and 018 over a six-month period.

- Model results show that approximately 6 percent of sitewide infiltration occurs within the stormwater ponds – therefore, less than 0.23 percent (or 6% of 3.8%) of rainfall becomes groundwater recharge through stormwater infiltration in the ponds
- The average infiltration rates at Silvernale and R-1, and were calculated to be 0.0006 and 0.03 inches per hour, respectively.
- Constituents of potential concern (COPCs) in stormwater (e.g., metals and dioxins) are predominately in particulate form, which minimizes their downward migration as they are filtered and sorbed by sediment in the pond and underlying soils.
- Limited samples collected to date do not exceed primary MCLs.
- **Modeling analyses and field calculations both confirm that stormwater infiltration in onsite ponds is very low.**
