Site-wide Stormwater Best Management Practices (BMPs)

Santa Susana Field Laboratory

Advanced Stormwater Treatment System Factsheet

**Area 1 Burn Pit Stormwater Capture and Conveyance Conceptual Design
Santa Susana Field Laboratory**

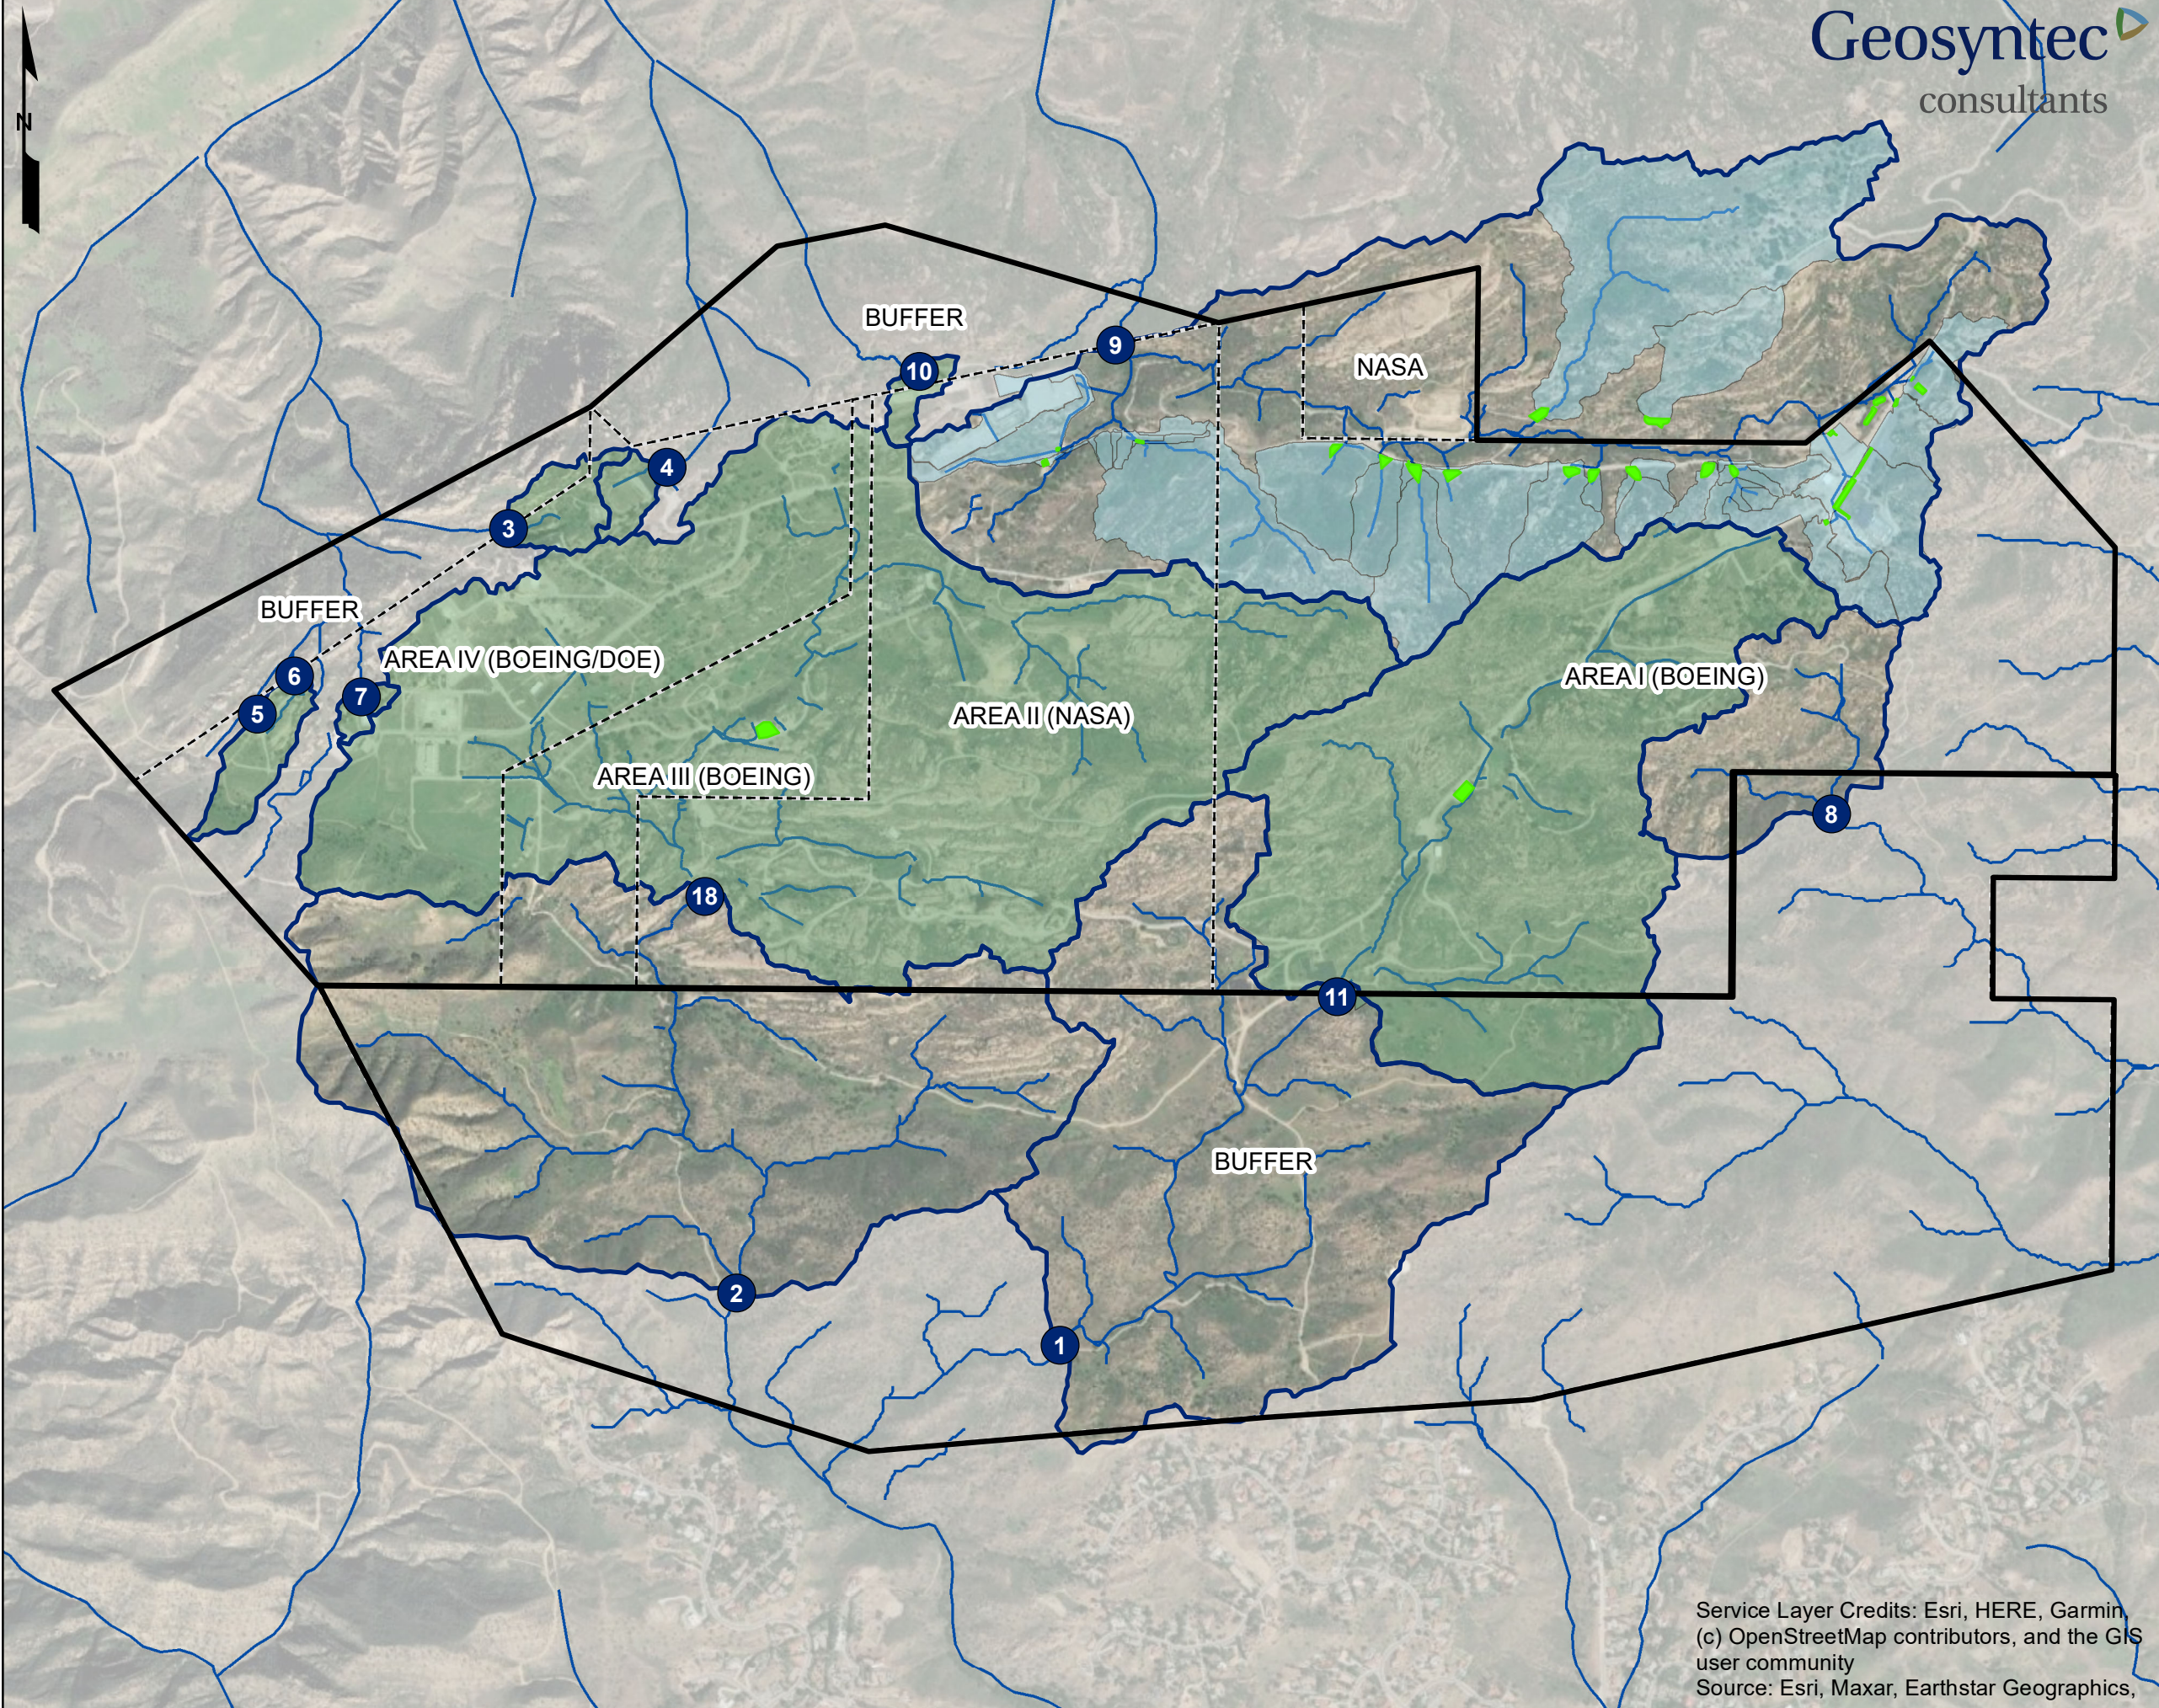
Santa Susana Field Laboratory
Ventura County, CA

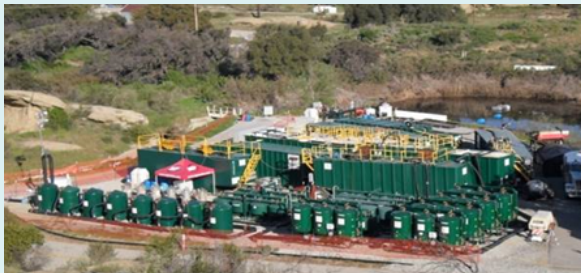
- **Implementation (2011):** Stormwater Treatment Systems (SWTSs) were established at Outfalls 011 and 018.
- **Advanced Treatment:** SWTSs employ coagulation and filtration systems for advanced stormwater treatment.
- **Upstream Management:** Existing ponds were strategically used to facilitate flow equalization and pretreatment sedimentation.
- **Stormwater Treatment:** When the pond volumes approach their storage capacity, advanced SWTSs are utilized to treat stormwater prior to discharge.
