**The Los Angeles Regional Water Quality Control Board**  
320 West Fourth Street, Suite 200  
Los Angeles, CA 90013

**Santa Susana Field Laboratory**  
**Site-Wide Stormwater Annual Report**  
**2022/23 Reporting Year**

CWR0801  
October 2023

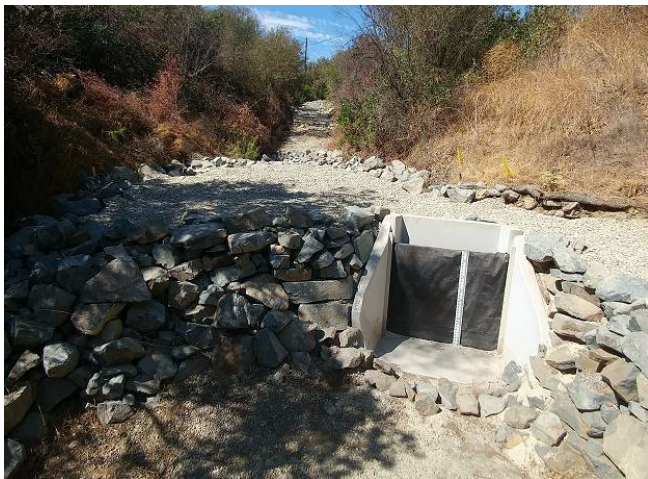
**2018: CM-1 Reconstruction Including Enlargement**

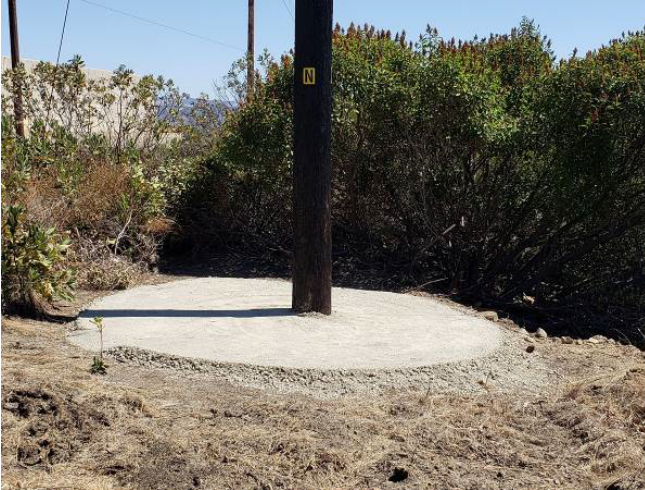
**2019: Area II Utility Pole Vegetation Clearing and Soil Base Stabilization**

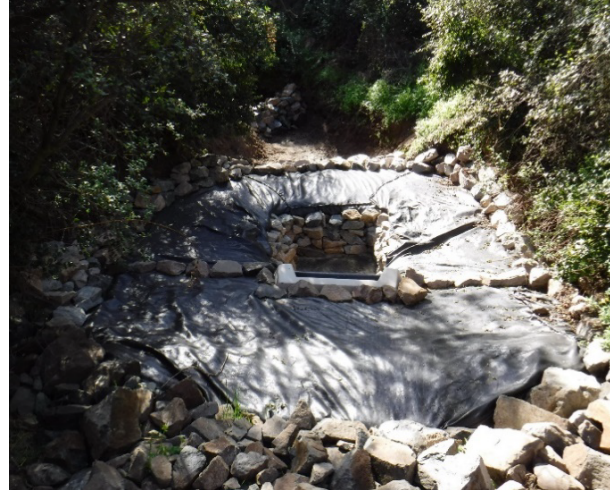
**2020: Outfall 009 CM-3 Check Dams Added and Filter Media Reconstruction**

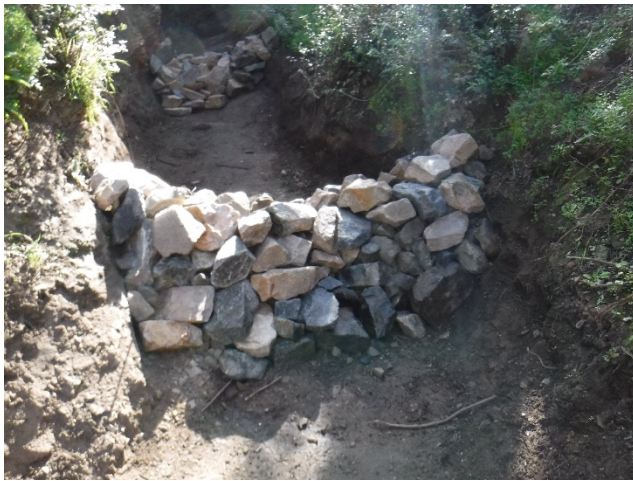
**2020: Outfall 009 CM-3 Check Dams Added and Media Filter Reconstruction**

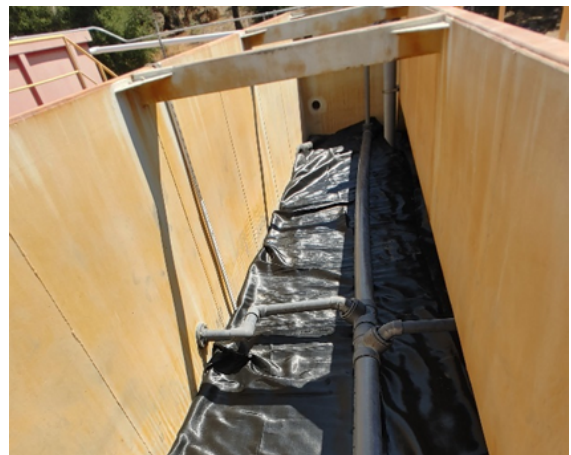
**2021: Outfall 009 ELV Treatment BMP Media Filter Reconstruction**

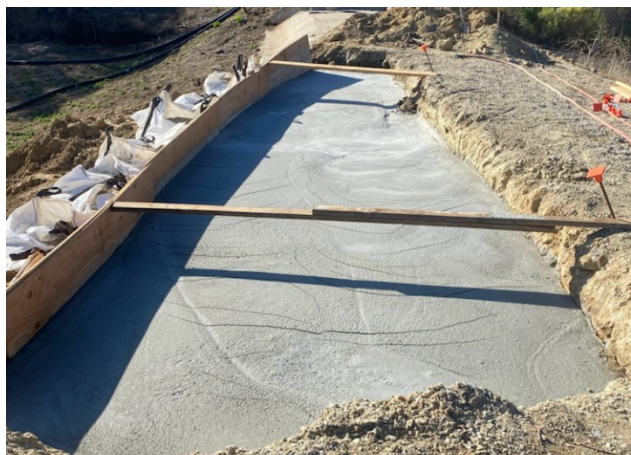
2022: R1 Pond Berm Repair

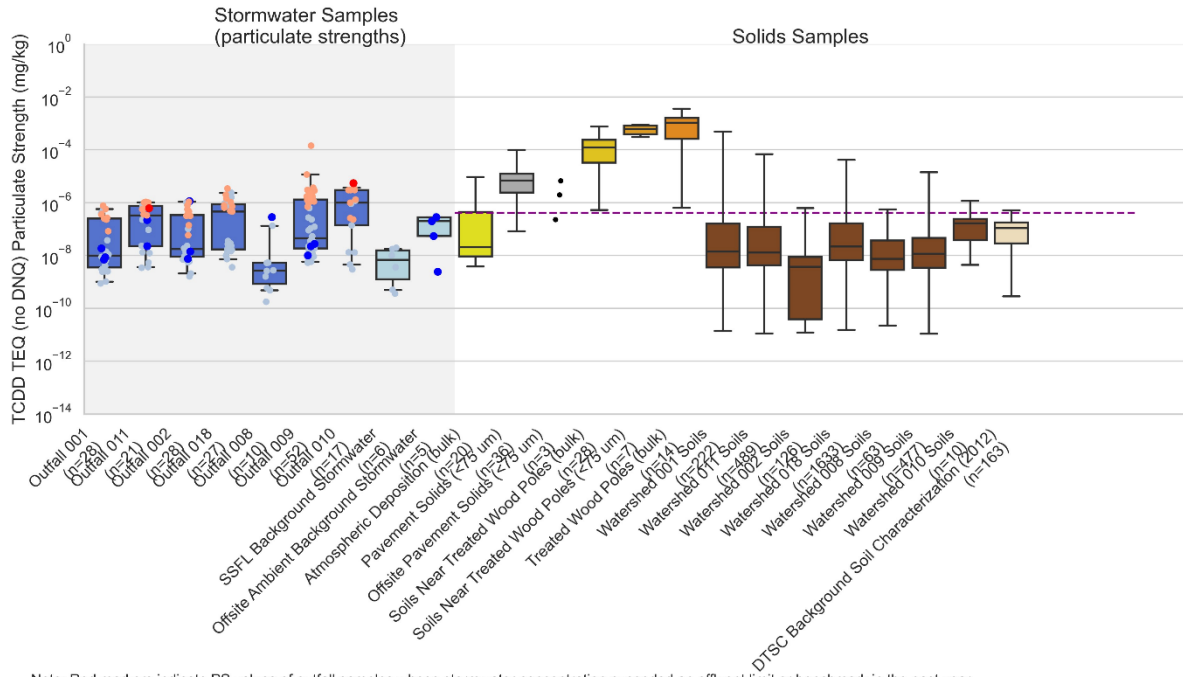
Figure 26. Dioxins PS (2022/23 Outfall Stormwater Samples) vs. Solid Source Materials

As shown in Figure 26, the exceeding samples had PS values that could have come from pavement solids, soils near treated wood utility poles, treated wood utility poles, and impacted soils (more likely at Outfall 011, whereas soils in the 010 watershed have lower dioxin concentrations). Of these sources, pavement solids and soils near treated wood have sufficiently high particulate strengths (about 10x to 100x the exceeding samples), quantity, and mobility onsite to be significant contributors of TCDD TEQ (no DNQ) in stormwater. Additionally, the highest soil concentrations found in potential cleanup areas in the Outfall 011 watershed are 1x to 10x the exceeding sample, indicating these soils could also have contributed to the exceedance. On the other hand, soil samples in the Outfall 010 potential cleanup areas have TCDD TEQ (no DNQ) concentrations more similar to background soils, so pavement and treated wood utility poles are a more likely source of the elevated PS in the exceeding sample. Together, this indicates the **TCDD TEQ (no DNQ) exceedances in stormwater were likely from pavement solids (<75  $\mu\text{m}$ ), soils near treated wood, impacted soils, and/or, background soils.**

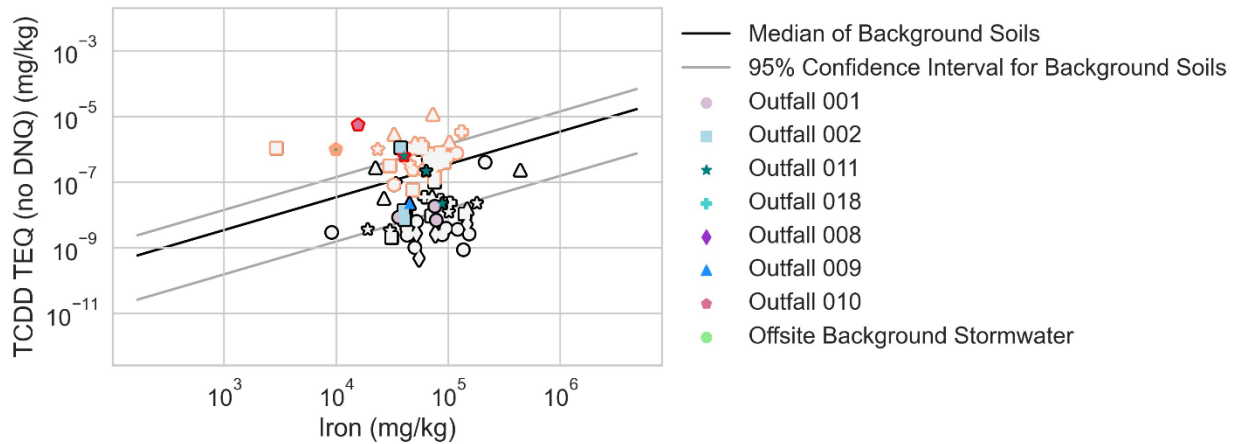
Figure 28. Dioxin vs Iron Metal Ratio Plot

The PS of TCDD TEQ (no DNQ) was compared against iron to evaluate if the stormwater ratios were consistent with natural background ratios. Figure 28 show that while most stormwater samples fall within the background soil 95% confidence interval, the exceeding samples are generally slightly elevated. The exceeding sample at Outfall 011 sample this year falls within the 95% confidence interval, which **supports background soils as a potential source of the 011 TCDD TEQ (no DNQ) exceedances** during the 2022/23 rainy season. However, the Outfall 010 exceeding stormwater sample falls outside of the background soil 95% confidence interval, which **indicates that other sources like pavement solids and treated wood are likely also contributing to the exceeding sample.**

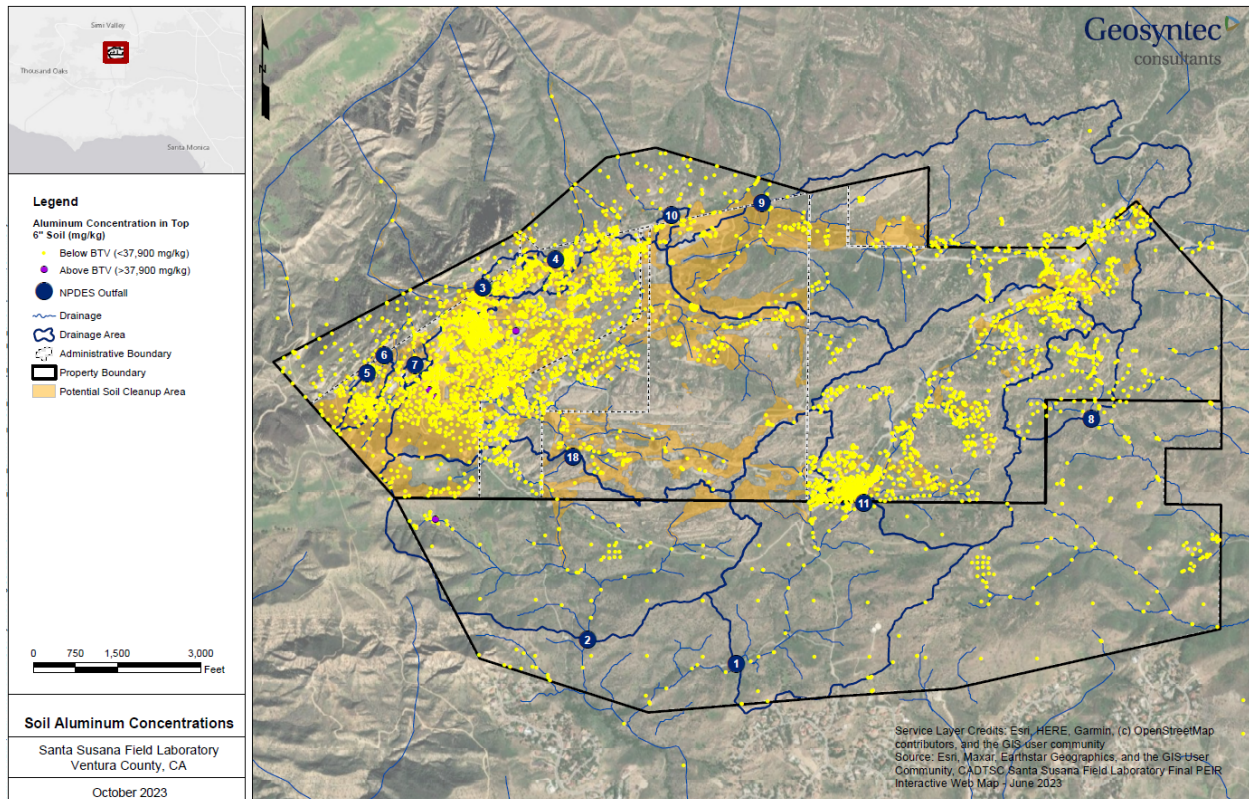
Figure 29. Aluminum Concentrations in SSFL Surface Soils (Top 6 inches)

The concentrations of aluminum in onsite soil samples collected from the top 6 inches were mapped over the potential soil cleanup areas identified in DTSC Potential Environmental Impact Report and colored to show ones below the background threshold yellow and those above purple (4 samples) in Figure 29. This figure demonstrates that aluminum concentrations in unimpacted soils across site are no different than aluminum concentrations in soil cleanup areas (orange shaded areas). As reflected in Figure 29, more than **99.9% of soil samples have aluminum concentrations below the background threshold value (BTV)**, which is further evidence that there are no industrial or impacted soil sources of aluminum at the site, and therefore aluminum exceedances in stormwater are likely from natural background soils.

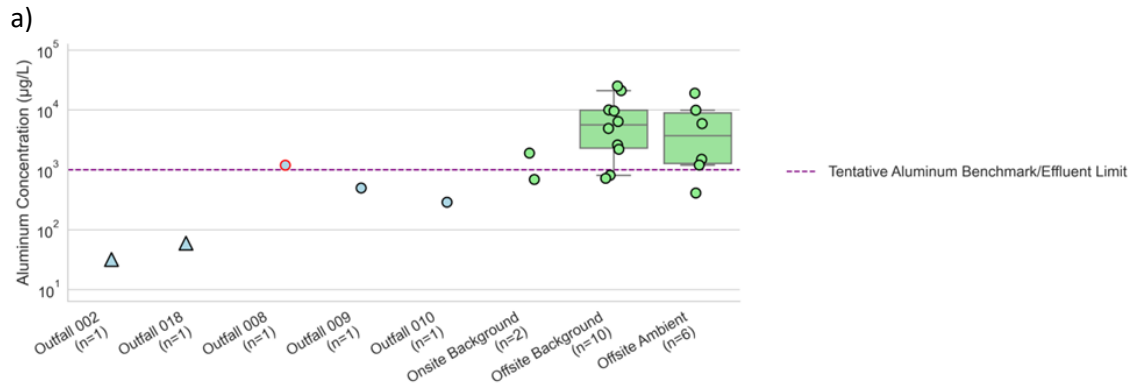
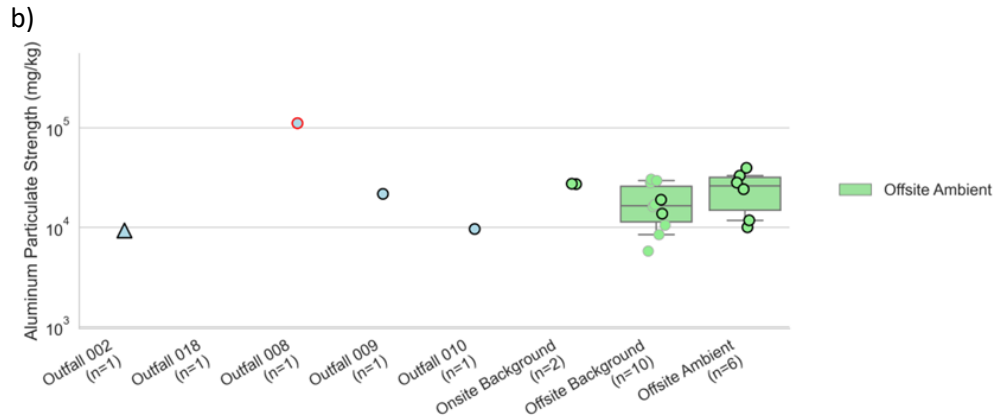
Figure 30. 2022/23 Aluminum Concentrations and Particulate Strengths by Outfall

Figure 30 shows the concentration of aluminum measured at the outfalls and background locations this year. **With only one sample per outfall location this year, there is not sufficient data to inform spatial trends.**

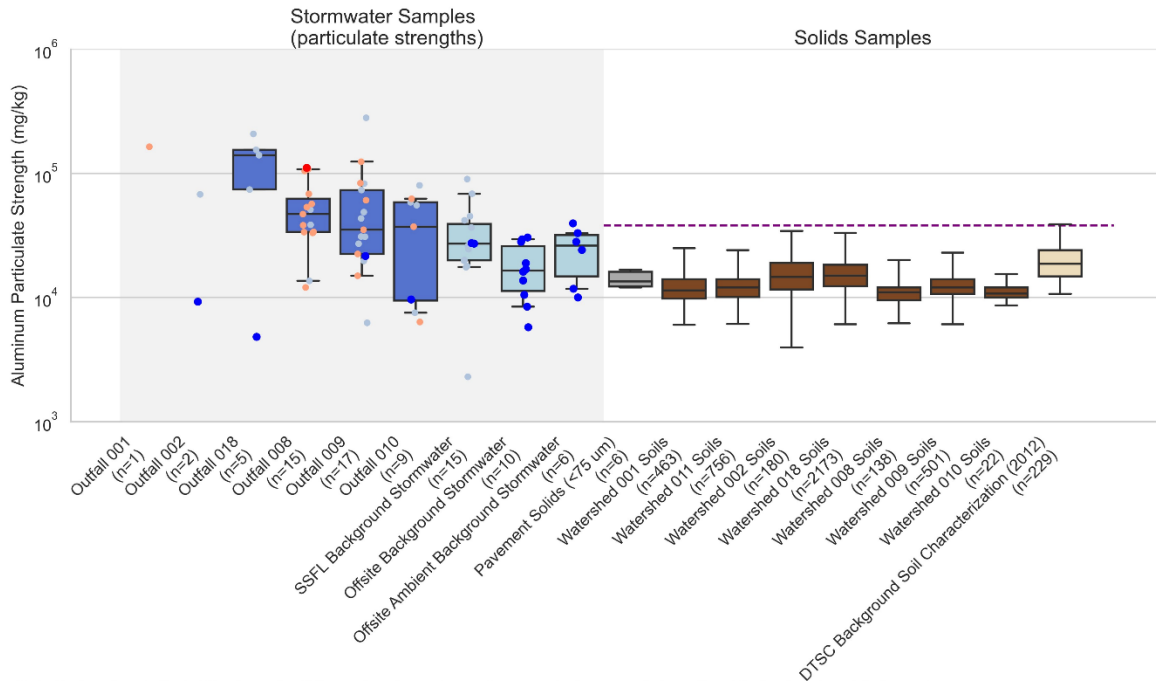
Figure 31. Aluminum PS in Outfall Stormwater Samples vs. Solid Source Materials

The PS of the outfall stormwater samples compared to the various potential sources are shown in Figure 31. The exceeding Outfall 008 sample’s PS was not below the 99<sup>th</sup> percentile of any of the sources evaluated. However, concentrations of aluminum at Outfalls 008, 009 and 010 were generally in line with concentrations found in background stormwater at SSFL Outfalls 001 and 002 have only one and two results, respectively, which is insufficient to draw any conclusions and Outfall 018 particulate strength is likely affected by the SWTS and reduced TSS. **The PS values of one exceeding sample could not be explained by the solid source samples evaluated, but is most similar to background stormwater. Most importantly, the elevated PS of this one exceeding sample cannot be explained by impacted soils since**

the 99<sup>th</sup> percentile of aluminum concentrations in soils in the NPDES watersheds are below the background threshold value and the same or lower than DTSC offsite background soil samples.

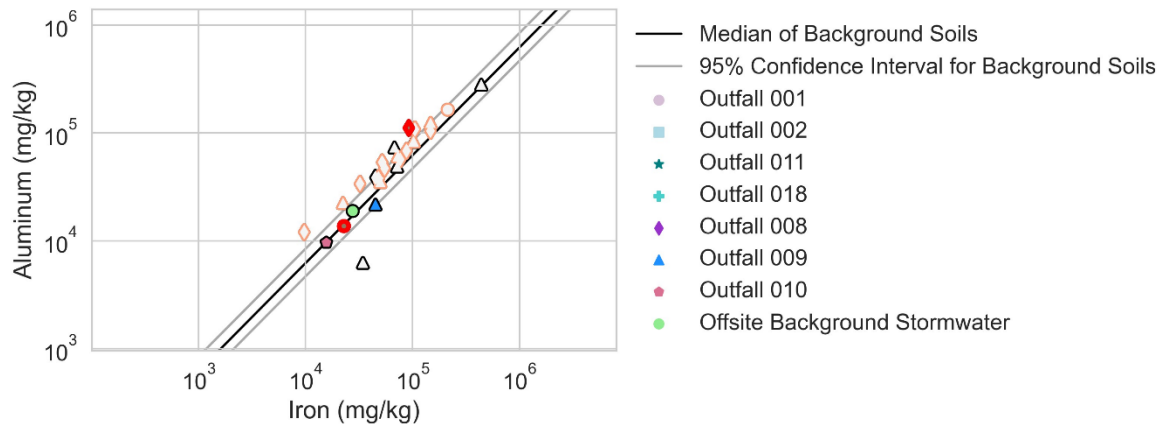
Figure 32. Aluminum:Iron Metal Ratio Plot

The PS of aluminum was compared against iron to evaluate if the stormwater ratios were consistent with natural background ratios. Figure 32 shows that this year's stormwater sample fell on the background soil 95% confidence interval, and nearly all the other stormwater samples also plot very tightly along the median line, which further supports that **background soils are a likely source of aluminum in the one 2022/23 exceeding sample and at all the outfalls in general.**

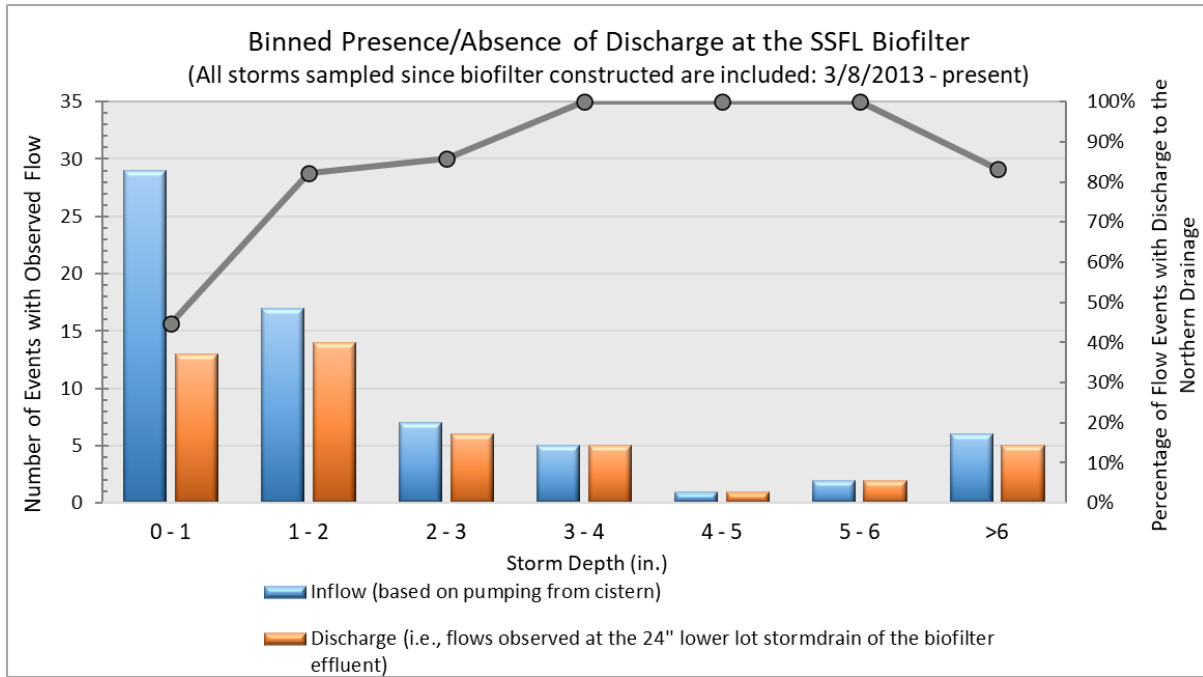
Figure 5 is a plot of discharging and non-discharging rain events for storms since the March 2013 implementation of the biofilter. This figure shows the quantity and types of storms in which the biofilter prevents discharge of stormwater runoff to the Northern Drainage. Storm events resulting in discharge to the Northern Drainage (via either the low-flow diversion weir bypass or treated biofilter effluent) were identified, categorized by total storm depth in one-inch increments, and compared to the total number of storms observed (where pumping from the cistern was recorded). Because stormwater runoff flows into the cistern and is then pumped to the lower lot biofilter, rain events are only counted in this analysis if pumping from the cistern occurred. The vertical axis on the right indicates the percentage of storm events that resulted in discharge to the Northern Drainage.

Smaller storms occur at a greater frequency than moderate and large-sized storms. As shown in Figure 5, it was estimated that the lower lot biofilter has successfully prevented discharges to the Northern Drainage in approximately 55% of storms of an inch or less of rainfall, 18% of storms between 1 and 2 inches of rainfall, and 14% of storms between 2 and 3 inches of rainfall.

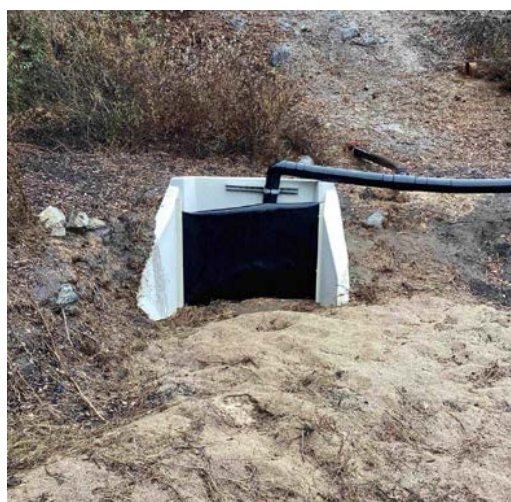
Figure 6. CM-4 on 11/08/2022

An example of sediment accumulation (at CM-4) is shown in Figure 6.

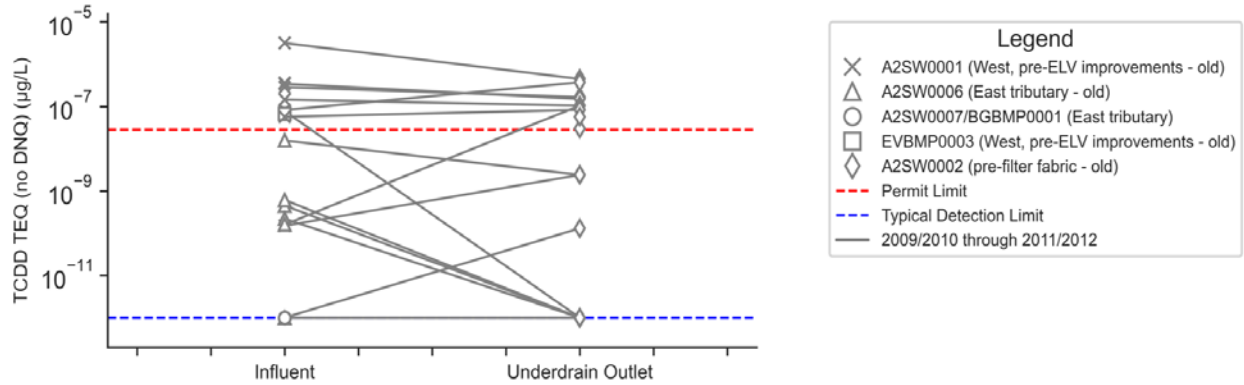
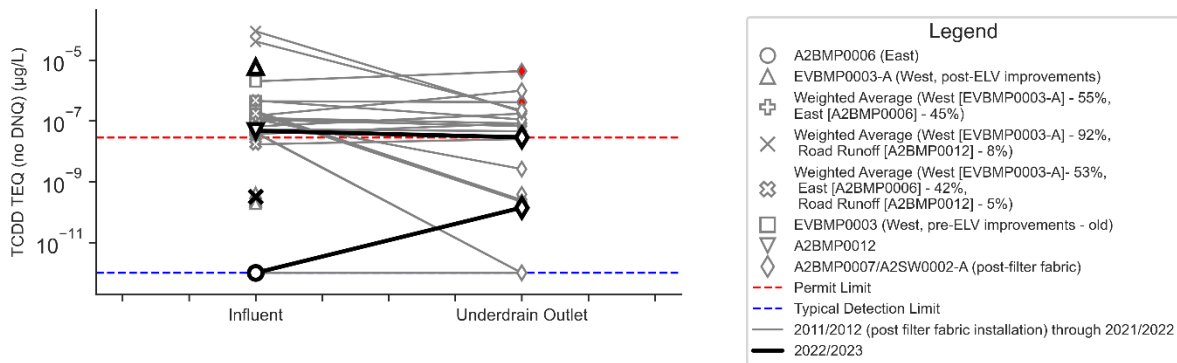
<sup>12</sup> Elevated influent concentrations plotted in Figure 23 and Figure 24 may have resulted from runoff contributed by a roadway area including several treated wood utility poles.
