787 Lithium-ion Battery Events

A Guide for Fire Fighters

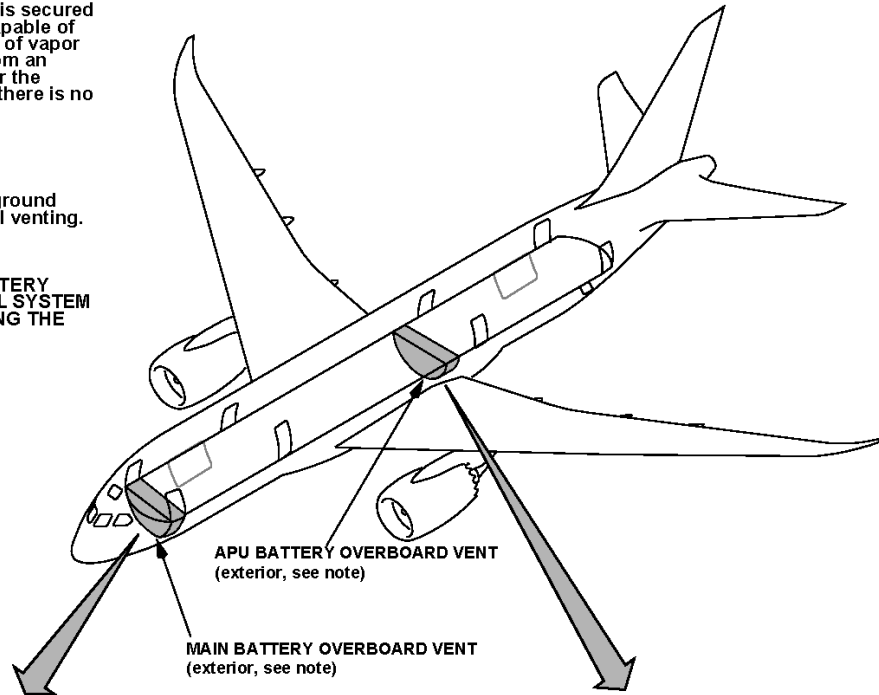
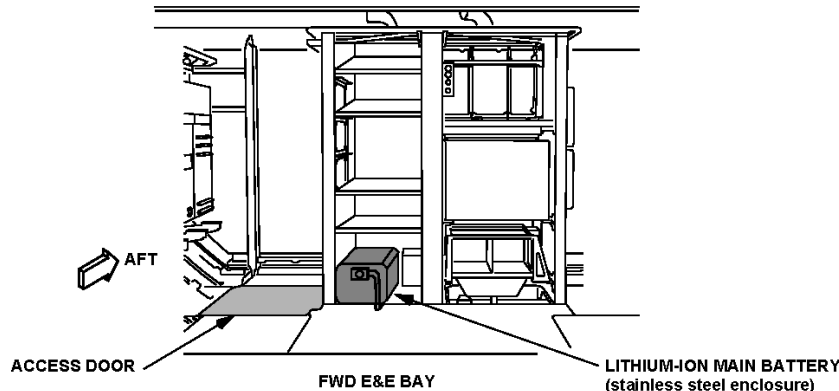
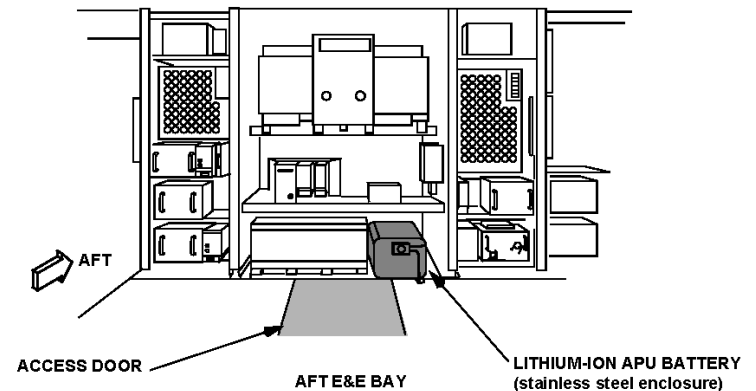
787 Battery Locations

Lithium-ion Batteries

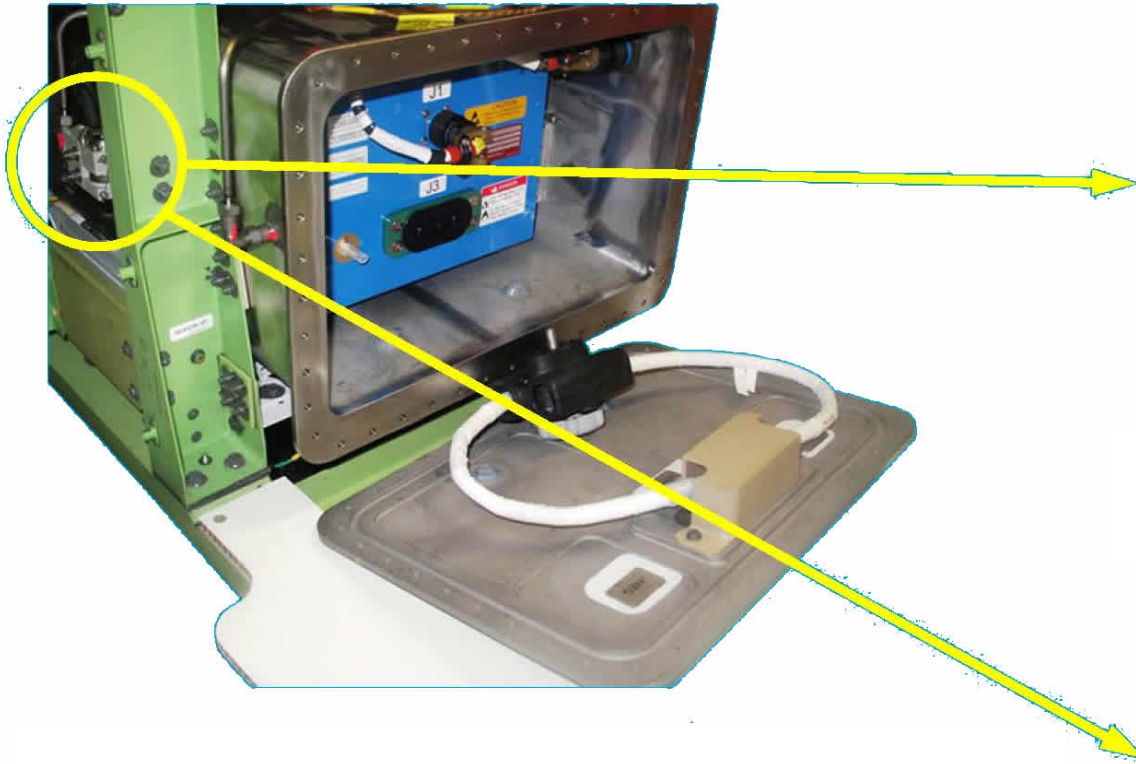
787 Main Battery Enclosure Pressure Burst Disc

Pressure Burst Disc Indicator
Main Battery Pressure Burst Disc Indicator shown,
APU Battery Pressure Burst Disc Indicator is the same

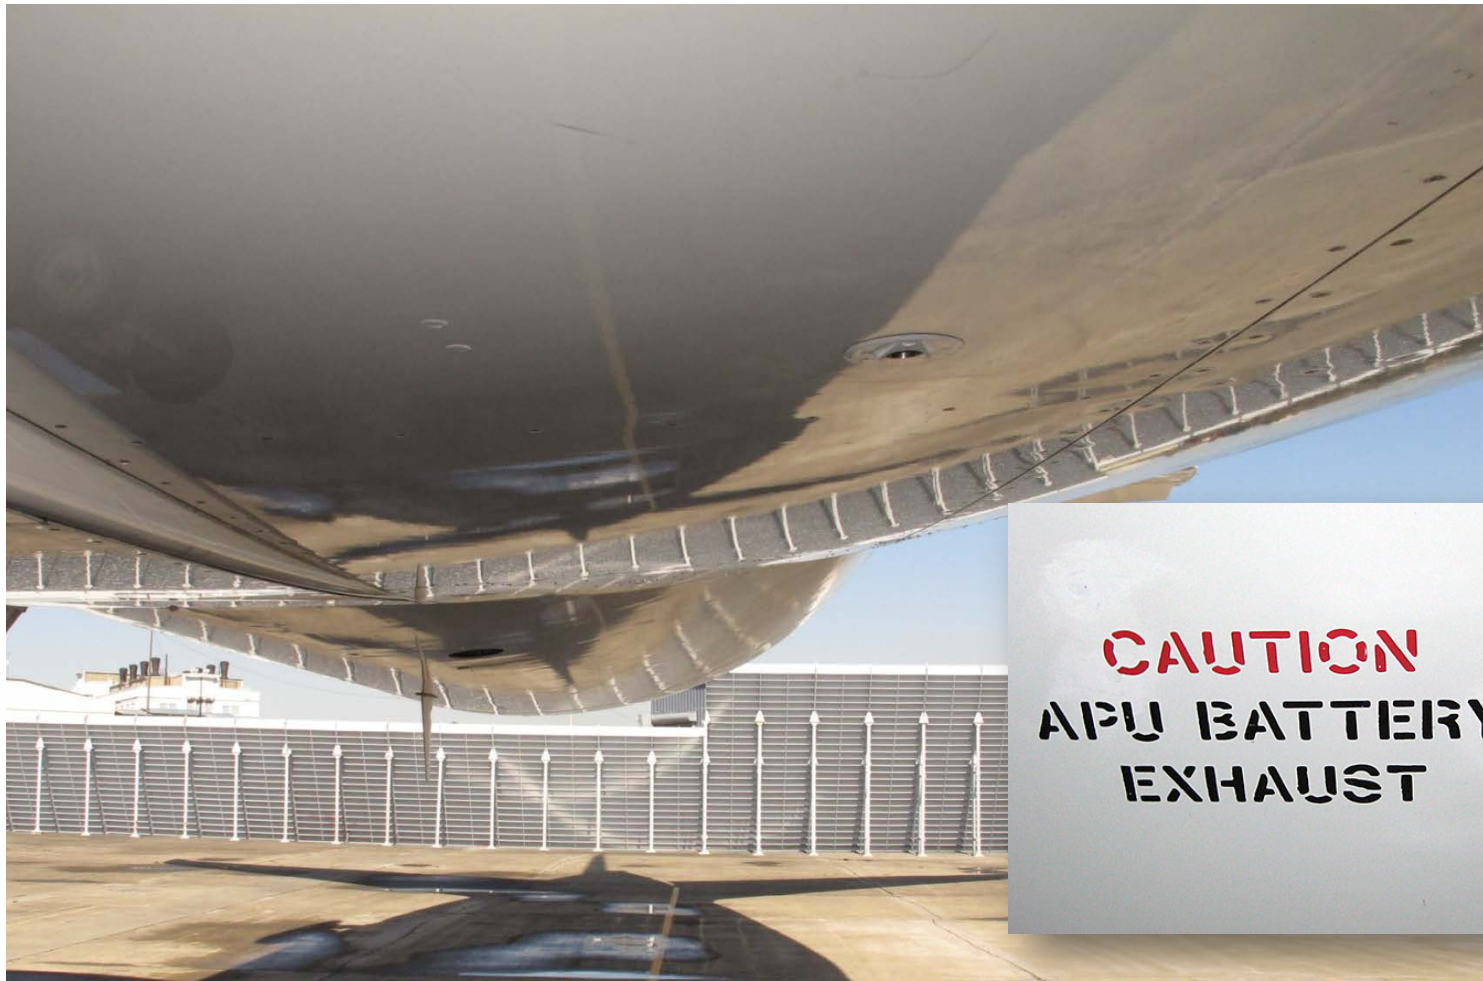
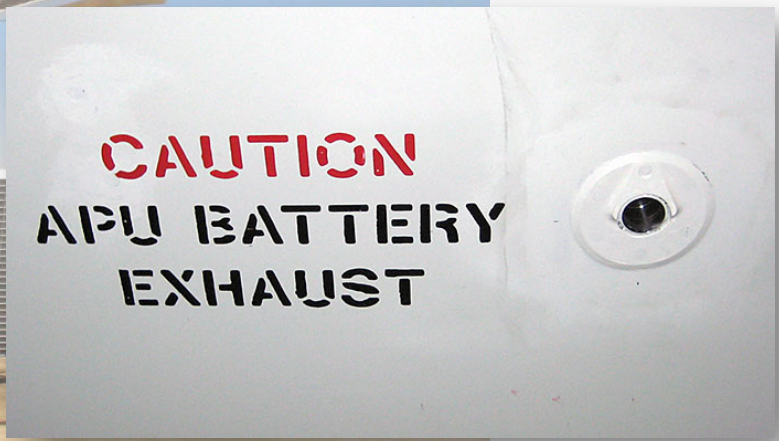
787 APU Battery Vent Port

CAUTION
APU BATTERY
EXHAUST

The box containing the lithium-ion battery cells is secured inside a reinforced stainless steel enclosure capable of containing a lithium-ion battery event. Venting of vapor during a battery failure event may be visible from an exterior vent on the bottom of the airplane under the forward or aft Electrical and Electronic (E&E) bay.
